Successful Return to Flight of the H-IIA Launch Vehicle

Since the failure of H-IIA flight No.6 in November 2003, launch of H-IIA had been suspended. To make H-IIA launch resume through lessons learned from this failure, corrective actions were taken not only to improve the cause of failure itself but also to improve the H-IIA reliability through re-evaluation of overall H-IIA development process. Then the improved H-IIA was launched on February 26, 2005 and returned to flight successfully. This paper describes the activities for the return to flight of H-IIA and the results of the flight.

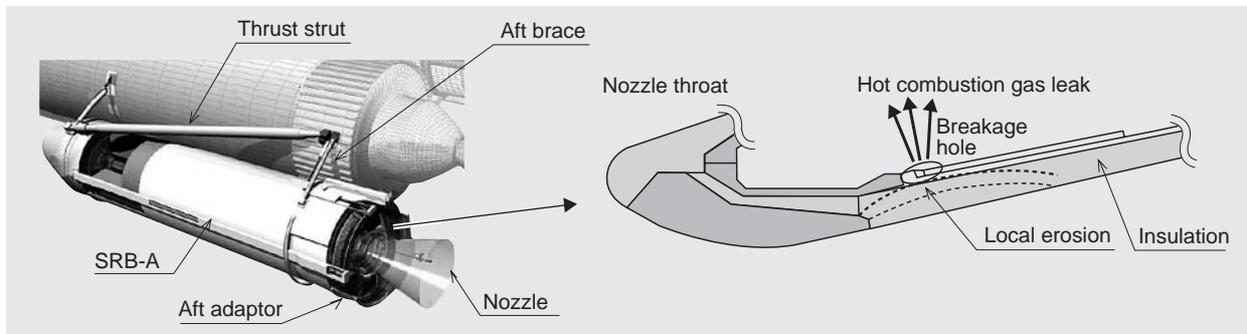
Fig. 3 Cause of the Flight No. 6 accident The figure shows the cause of the flight No.6 happened in the SRB-A nozzle.

The accident investigation revealed that the malfunction of right side SRB-A separation was caused by hot combustion gas leakage from a breakage hole on the SRB-A nozzle which was formed by local erosion of nozzle inner insulation. The cause of failure identified by accident investigation is as follows (**Fig. 3**):

- (1) Local erosion of the inner CFRP insulation of nozzle, by a combustion gas jet, formed a breakage hole on the nozzle
- (2) Hot combustion gas leaked through the hole on the nozzle.
- (3) The leaked hot gas burned components including detonating fuse responsible for sending separation signal
- (4) The signal to jettison the SRB-A was sent but the booster failed to separate.

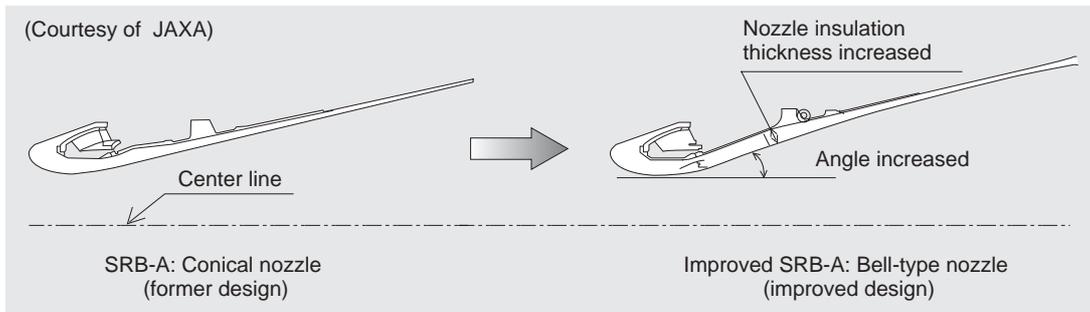
Fig. 4 Improvement of SRB-A nozzle The figure shows the improvements made to the SRB-A nozzle.

As a result of the activities, it was decided that the improved SRB-A should incorporate the following measures to prevent local erosion of the nozzle insulation (Fig. 4):

- Relaxation of combustion pressure
- Adoption of a bell-shaped nozzle
- Increase of wall thickness of nozzle

These countermeasures were verified by ground firing tests, and accordingly it was approved to apply the improved SRB-A to the return-to-flight vehicle.
