# Development of Maintenance Guidelines for Dissimilar Metal Welds of Low-Alloy Steel Boiler Tube

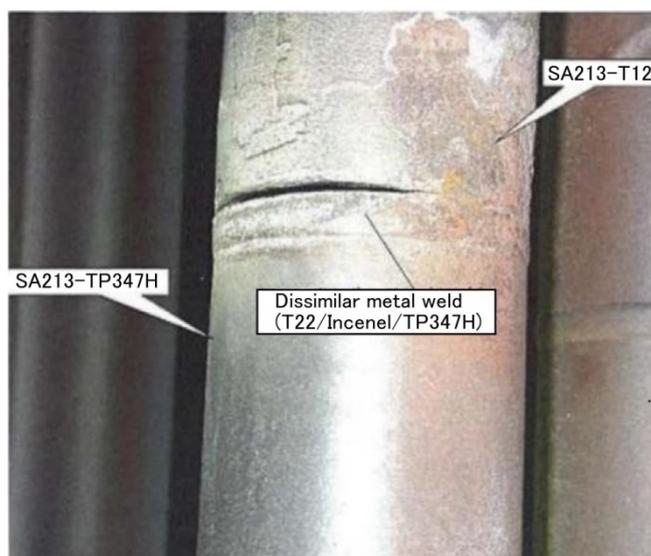
Heat transfer tube of boilers, which are one of the main pieces of equipment of thermal power generation facilities, are often exposed to severe environments under high temperatures and high pressures. This results in failures of the fusion line at DMW of heat transfer tube, which is the generation and propagation of cracks along the fusion line between the base metal and the weld (**Figure 1**)<sup>(2)</sup>. Since such failures found in the past in our group occurred only in DMW that had undergone repair welding, we have taken measures such as not allowing repair welding when manufacturing joints. Since 2015, however, it has been confirmed that this failure occurs after long-term use even in areas other than repair welds. In addition, according to a report<sup>(3)</sup> by EPRI (Electric Power Research Institute), etc., similar failures have occurred not only in the boilers manufactured by our group, but also in those manufactured by other companies, so this is a common problem worldwide.

**Figure 1** Example of failure on fusion line of dissimilar metal weld

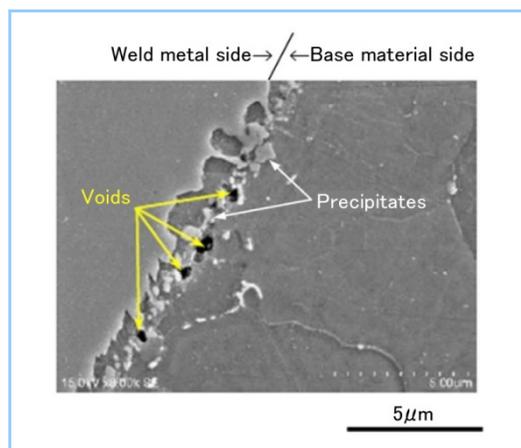
**Figure 2** shows the cross-sectional observation results of the failure of the fusion line that occurred on a boiler heat transfer tube low alloy steel DMW. This failure is the generation and propagation of a crack along the fusion line caused by voids (vacancies) generated in the fusion line on the low alloy steel side. Strictly speaking, voids and cracks often occur at a location on the low alloy steel side, about several micrometers from the fusion line. Another characteristic of this failure is that a row of precipitates and a decarburized layer (**Figure 3**) are formed near the fusion line due to the atomic diffusion between the weld metal and the base metal.

**Figure 2** Example of cross-sectional observation of failure on fusion line using scanning electron microscope

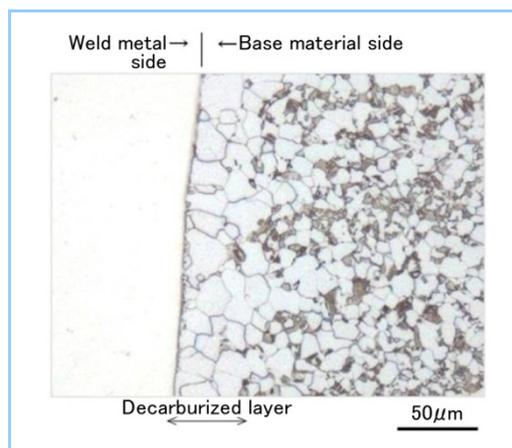
**Figure 3** Observation example of decarburized layer formed near fusion line

with less creep deformation resistance than the surrounding structure makes it easier to accumulate creep strain. This decarburized layer is formed by atomic diffusion between the weld metal and the parent phase due to heat input during welding and is observed in both superheater tubes and reheater tubes.

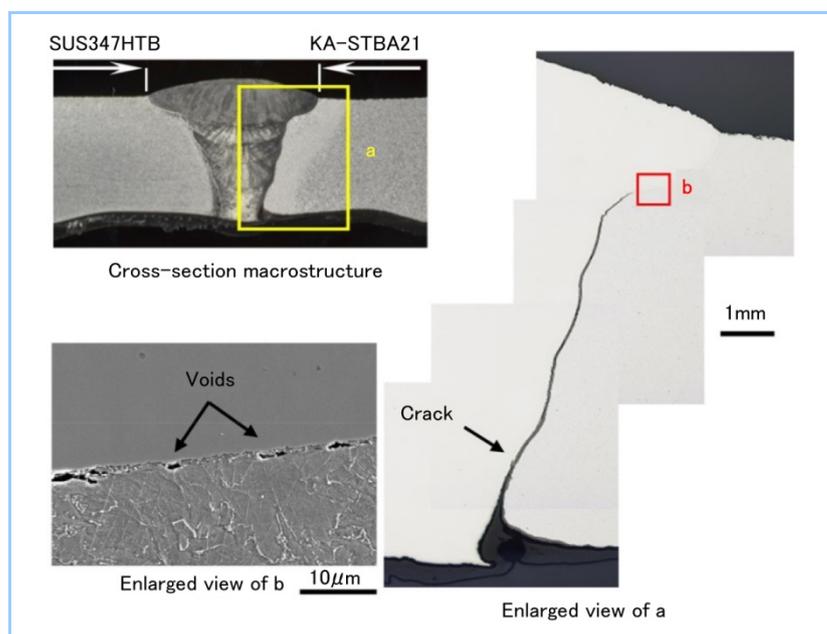
**Figure 4** shows a typical example of the failure of a fusion line. Failures found in the past in our group occurred only on the DMW of a superheater tube and no failures occurred on the DMW of a reheater tube. This failure was considered to be rare because there were few cases that led to a leak accident. However, recently a crack was detected by UT (Ultrasonic Test) as shown in Figure 4, so this failure should be subject to maintenance.

**Figure 4** Examples of crack detected by UT inspection

Since this failure often occurs from the inside of the wall thickness or the inner surface side of the tube, UT inspection was adopted. UT inspection uses our proprietary thin UT probe and the unique flaw detection sensitivity and detection standard value are set based on a simulation and actual equipment inspection results, which results in the minimum detectable failure size of 1 mm.

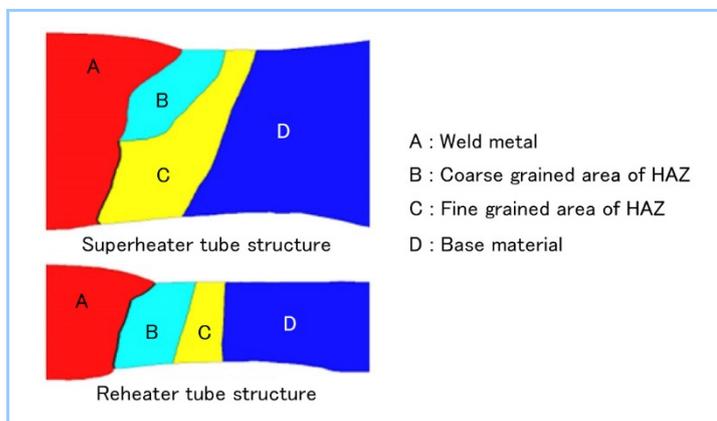
In order to investigate the mechanism of this failure, we first identified the factors that affect this failure. Specifically, we compared and arranged the design conditions and operating conditions of the failure material and non-failure material and conducted metallurgical investigations such as cross-section survey and chemical analysis. During the metallurgical investigation, it was found that there is a difference in the structural composition of the HAZ (Heat Affected Zone) between the superheater tube and the reheater tube (Figure 5 and Figure 6). As described above, since no failure has occurred on the DMW of reheater tubes, it was hypothesized that this difference in structural composition is one of the factors that affect the failure.

**Figure 5** Difference in the structural composition between superheater tube and reheater tube

- (1) The structural composition of a heat transfer tube DMW differs between superheater tubes and the reheater tubes (Figure 5 and Figure 6). In the case of superheater tubes, the fine grain area of HAZ is located from the inner surface side of the tube near the fusion line to the center of the tube thickness. In a low alloy steel dissimilar joint, since the creep deformation resistance of the fine grained area of HAZ is higher than the creep deformation resistance of the coarse grained area of HAZ\*, stress redistribution due to creep during operation occurs and high axial stress is generated on the inner surface side of the tube or near the center of the tube thickness (Figure 7). This axial stress includes not only the axial stress due to the internal pressure, but also the tensile bending stress caused by the difference in thermal expansion between the stainless steel, weld metal and low alloy steel.

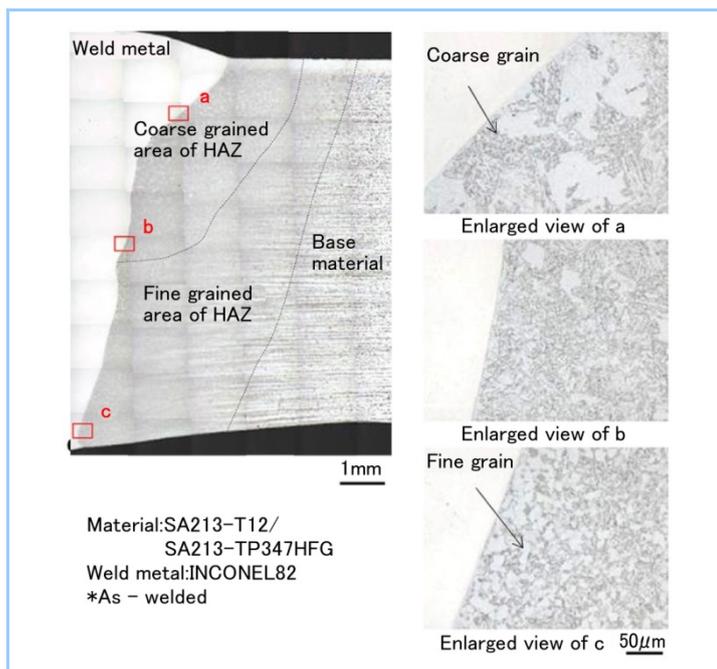
**Figure 6** Typical example of superheater tube structural composition

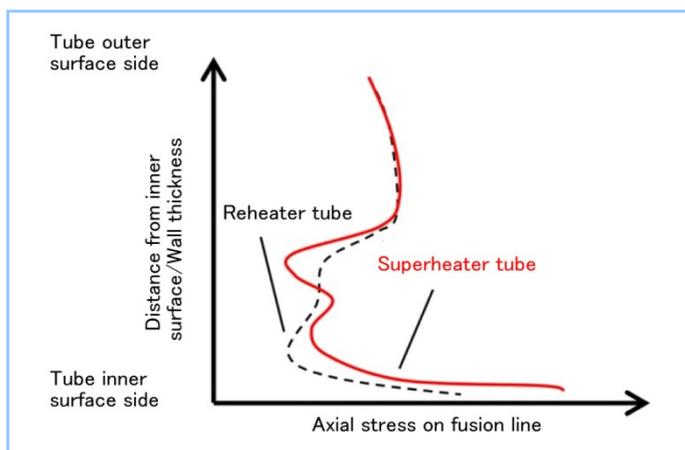
In order to verify this hypothesis, we performed elastic — creep analysis by FEM under the same conditions except for the structural composition. As a result of the FEM analysis, it was clarified that the difference in structural composition causes a difference in the axial stress required for the generation and propagation of cracks, so it was found that a difference in structural composition can be one of the factors that affect failure (Figure 7). In addition, as a result of FEM analysis of several models we created, it was clarified that the higher the base acting stress (axial stress due to internal pressure), the higher the axial stress acting on the fusion line, so it was found that the magnitude of this acting stress can also be one of the factors that affect failure (Figure 8).

Figure 7 FEM analysis result image

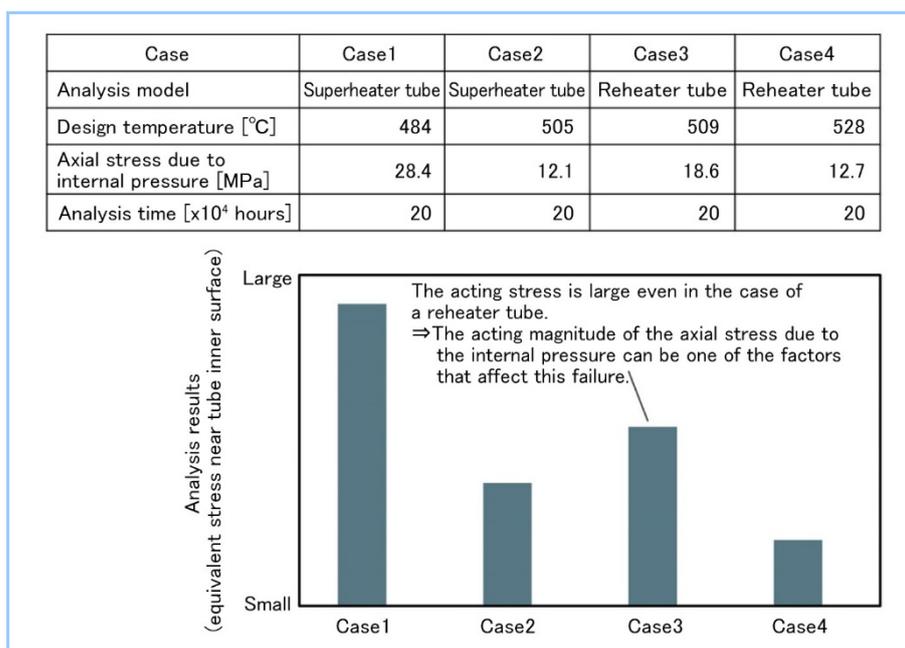
Figure 8 Comparison of FEM analysis results using multiple models

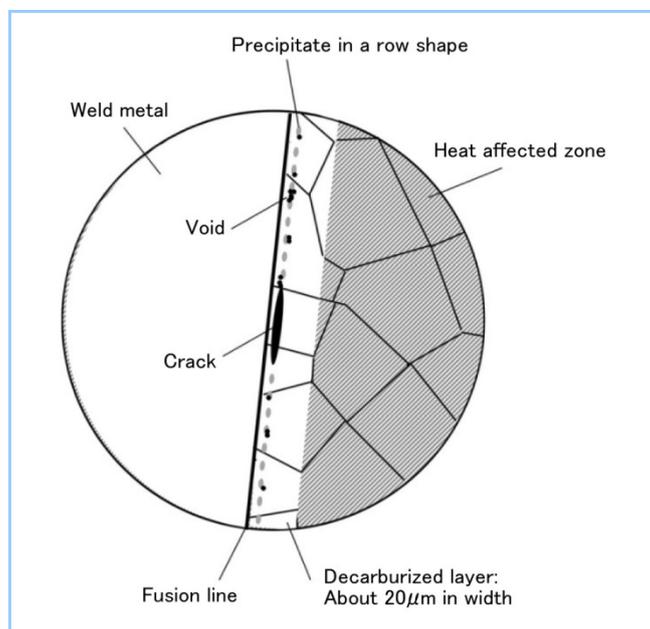
- (4) Furthermore, due to the difference in Cr concentration between the parent phase and the weld metal, precipitates such as  $M_{23}C_6$  and  $M_6C$  are formed in the decarburized layer mainly in a row shape (Figure 9).
- (5) Due to the accumulation of creep strain during operation, atomic vacancies are likely to accumulate at the fusion line between the precipitate in the decarburized layer and the parent phase and creep voids are preferentially generated (Figure 9).
- (6) As the formation of voids progresses, they are connected to each other, leading to the generation and propagation of microscopic cracks and eventual fractures.

Figure 9 Schematic view of failure
