# High-Efficiency Cutting of Super-Heat-Resistant Alloy

Keiichi Yamamoto\*<sup>1</sup> Motofumi Kuroda\*<sup>1</sup>  
Hidefumi Omokawa\*<sup>1</sup> Katsutoshi Itakura\*<sup>2</sup>

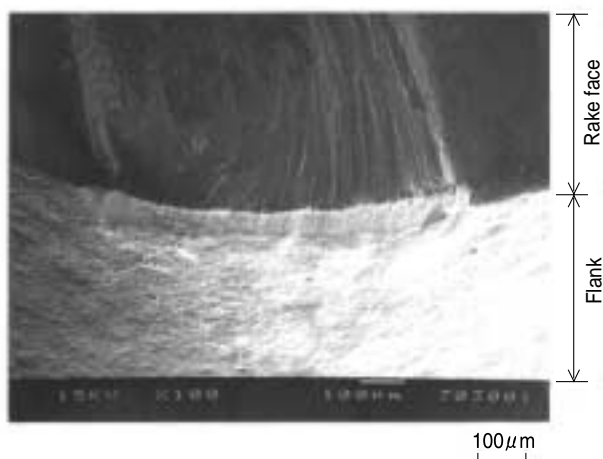
**Fig. 1 Tool after cutting 30 m (cutting speed: 30 m/min)**

The photograph shows the diagonal direction and from the upper direction. Inconel 718 is adhered to the rake face.

**Fig. 1** shows the result of observation by SEM of the tool after Inconel 718 was cut to a length of 30 meters. It was found that the adhesive of the Inconel 718 workpiece was deposited on the rake face of the tool.

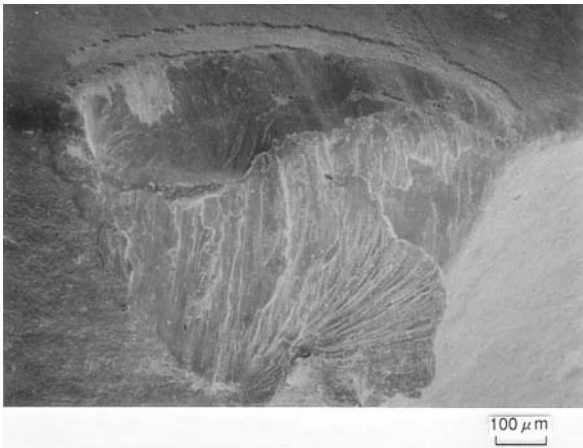
**Fig. 4 Tool after cutting 69 m (cutting speed: 100 m/min)**

The rake face and flank are greatly worn at a cutting length of 69 m and further cutting becomes impossible.

The tool wear was observed at the standard cutting speed of 30 m/min and when cutting is at a high speed, it is known that the tool is instantaneously worn. Therefore, it was determined that the wear behavior should be examined during high speed cutting. **Fig. 4** shows the tool wear when Inconel 718 is cut for 69 meters at a cutting speed of 100 m/min. Wear of both

the rake face and flank had greatly progressed by a cutting distance of 69 meters and further cutting was not possible. Also cutting was performed several times under the same conditions, but the same tendency was obtained in all cases.
