Improved Technologies of Steam Turbine for Long Term Continuous Operation

SUMIO NODA*1 YOSHIKAZU YAMADA*2
 SATORU ZENITANI*2 TOMOYOSHI SASAKI*3

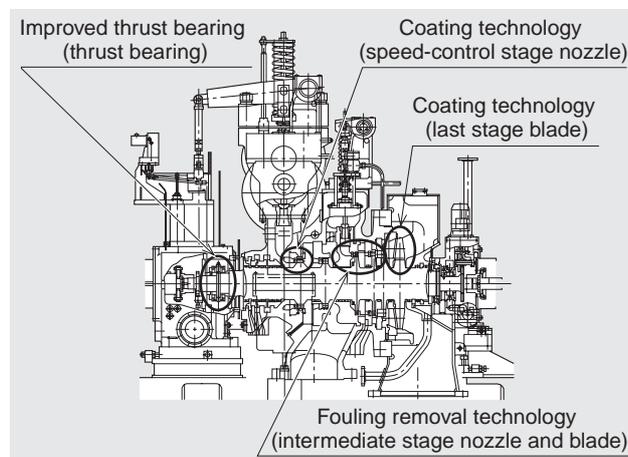
Fig. 2 Section drawing with applying of new technologies

Fig. 2 shows the section of the steam turbine, with the improved technologies in the parentheses above indicating the examples of the main parts where the said technologies are applied.

- (1) Improved thrust bearing (thrust bearing)
- (2) Coating technology (speed-control stage nozzle and last stage blade)
- (3) Fouling removal technology (intermediate-stage nozzle and blade)

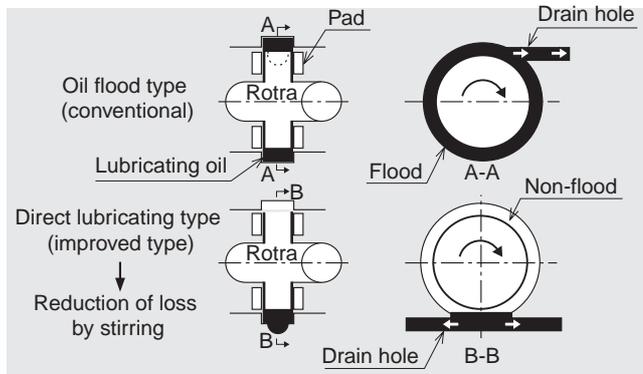
Fig. 3 Lubricating types compared

Fig. 3 shows the diagrams of flood type and direct lubricating type.

The bearing was conventionally filled with lubricating oil in order to maintain high reliability. However, the weakness such as the problem of temperature rise in bearing metal due to high-temperature lubricating oil of the upper side pad, the increase in bearing loss due to resistance of lubricating oil by stirring at the outer periphery of thrust collar, etc. have come to the surface as the speed increases.

As a solution to this problem improvements were made in the bearing characteristics by adopting direct lubricating system, aiming at non-flood.

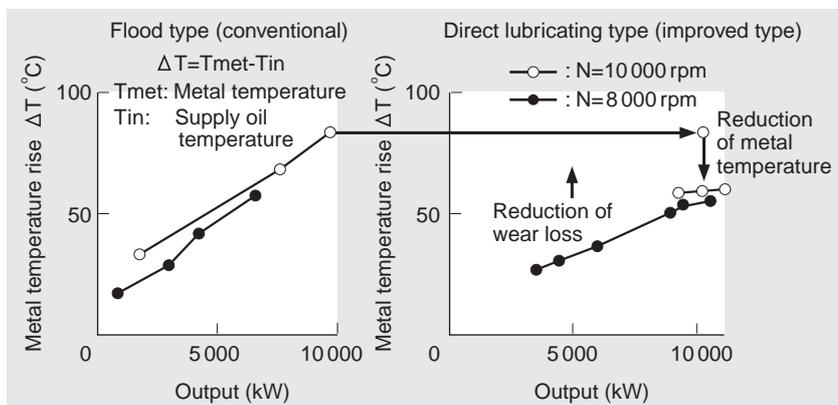
Fig. 4 Comparison of bearing metal temperatures

Fig. 4 shows the temperature rise in thrust pad of conventional type and direct lubricating type caused by changes in turbine output and rotational speed. In Fig. 4, the effect of reduction of temperature rise in thrust pad by direct lubrication can be confirmed through all zones of load, indicating substantial reduction in high-load zone especially.

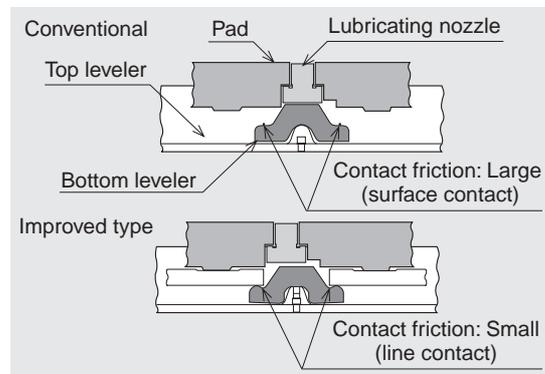
Fig. 5 Comparison of levelers

The contact surfaces of top/bottom levelers were conventionally surface contact with comparatively large frictional resistance. In order to reduce the frictional resistance the contact surface in the improved leveler has been changed to line contact to improve the leveling capability. (Fig. 5)

of thrust bearing. It recovers the relative inclination between thrust collar and bearing, during turbine operation. The top/bottom levelers, installed to the bottom of the pad, change their positions against the nonuniform load between pads, according to the dynamic balance conditions. As a result, the up-down movement of the pad absorbs the relative inclination.

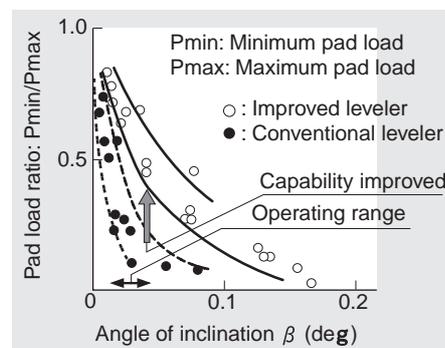
Fig. 6 Leveling capability compared

Fig. 6 shows the leveling characteristics of conventional and improved levelers, with the thrust collar inclination angle and pad load ratio compared and summed up. The result clearly showed that the improved leveler had a more moderate reduction of pad load ratio than the conventional leveler against the increase in the

angle of inclination, ensuring drastic improvement in the leveling capability.

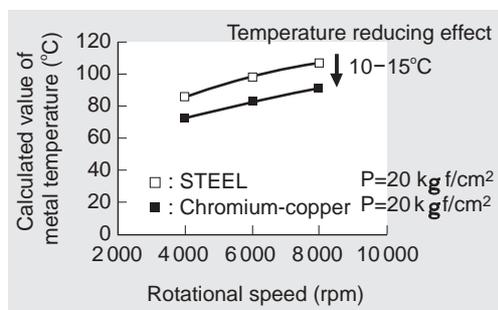
Fig. 7 Back metal material compared

The adoption of chromium-copper with high thermal conductivity is expected to reduce the temperature by 10 to 15°C as compared with the steel bearing (Fig. 7).

Conventionally steel is adopted as the back metal of bearing pad. However, the improvement of the thermal conductivity of bearing pad can be considered as a means to reduce the bearing temperature.

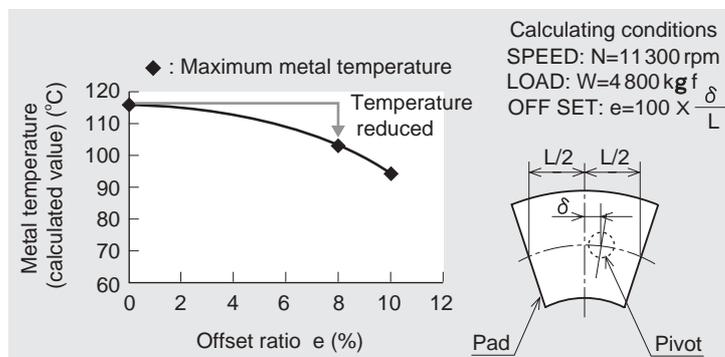
Fig. 8 Offset ratio compared

The effect is shown in Fig. 8

The bearing temperature can be reduced by improving the load capacity of the bearing. The offset pivot making positive use of the wedge effect of oil film can be a good means to this regard.

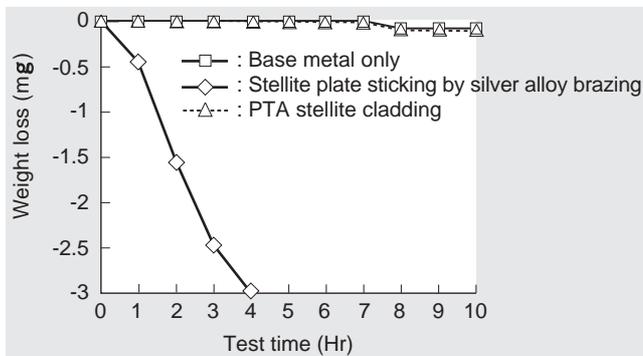
Fig. 11 Erosion resistance

Fig. 11 shows the erosion resistance of PTA measured from the cavitation and erosion tests conducted according to ASTM G32-77 (environment: ion-exchange water, temperature: room temperature, test frequency: 18.3 kHz, test-piece end amplitude: 25 μm) and compared with silver brazing, indicating that the PTA has the erosion resistance equivalent to that of silver brazing.

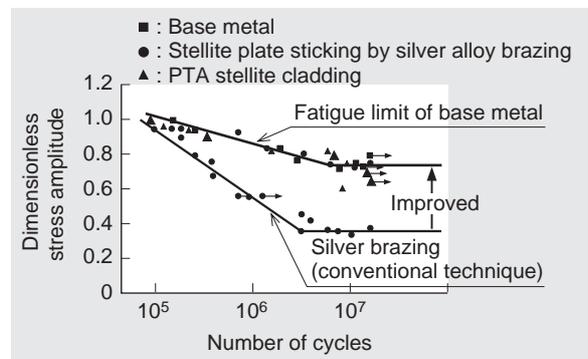
Fig. 12 Fatigue strength

Fig. 12 shows the fatigue strength of PTA evaluated by using Ono-type rotating bending fatigue test (environment: atmosphere, temperature: room temperature, frequency: 60 Hz) and compared with silver brazing, indicating that PTA has excellent fatigue strength characteristics while silver brazing has the fatigue strength reduced approximately to half of the base metal.

In view of the aforesaid points, the protected area (stellite section) in conventional method was limited to the blade tip. In the case of PTA, however, since the fatigue strength equivalent to that of the base metal can be obtained, the welding is possible up to the central portion of the blade. Thus, with the protected area expanded, application of PTA is expected to get expanded to strict erosive environment. Further, the stellite plate had problems such as difficulty in molding and necessity of manual work, whereas in the case of PTA, the welding is carried out mechanically, bringing about considerable improvement in quality and yield.

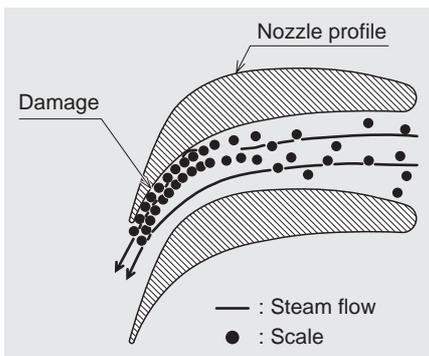
Fig. 13 Mechanism of nozzle wear damage

Fig. 13 shows the mechanism of nozzle wear damage.

The scale is generated and grows into the inner surface of the boiler tube due to steam oxidation; the enlarged scale then gets break away because of the weakening of its adherence to the base metal of the tube at the time of start/stop of the plant before finding its way into the turbine.

Since the flow direction while passing through the nozzle profile gets sharply changed, the scale with larger specific gravity fails to catch up with the steam flow because of the effect of inertia and gets collided with the nozzle profile, causing wear damage. This is what we call solid particle erosion. Particularly the speed-control stage nozzles installed at the inlet of the turbine have larger damage.

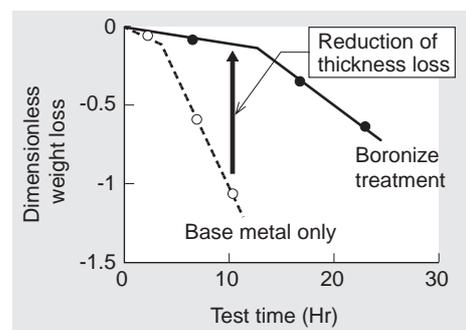
Fig. 14 Solid particle erosion test compared

Fig. 14 shows the test results of resistance to solid

particle erosion with or without boronize treatment, indicating that the wear loss of the nozzle subjected to boronizing is extremely less than that of the nozzle without boronize treatment. For example, the wear loss of the nozzle subjected to boronizing after a 10-hour test is approximately one-tenth of the nozzle without boronize treatment.

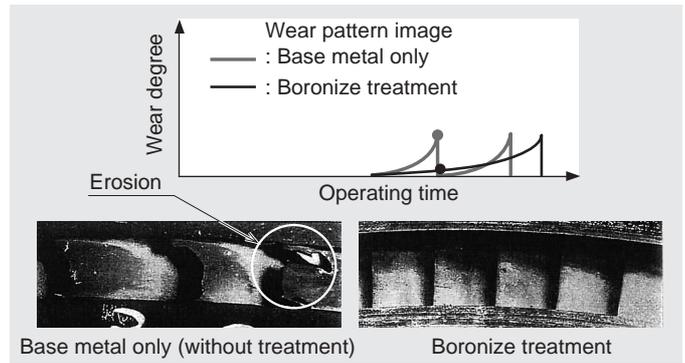
Fig. 15 Appearance of speed-control stage nozzle compared

Fig. 15 shows the appearance of the actual speed-control stage nozzle subjected to boronizing compared with the appearance of the nozzle without boronize treatment. The damage is clearly visible at the outlet end of the nozzle without boronize treatment, which is not seen in the nozzle with boronize treatment, indicating the effectiveness of surface hardening treatment.
