Completion of Turbine Replacement with 54-inch Blade Low Pressure Turbine at KRSKO Nuclear Power Plant with Very Short Outage Period

KRSKO Nuclear Power Plant (700 MW class) in the Republic of Slovenia replaced its low-pressure turbine rotor with a monoblock type low-pressure turbine from Mitsubishi Heavy Industries, Ltd. (MHI) as a measure against stress corrosion cracking in April 2006. The replacement work was completed in a very short period, 27 days, and the plant is now operating steadily with a satisfactory performance improvement. MHI longest blades, 54 inches, were fitted to this turbine for the first time in a plant. The turbine is made of low-strength material against stress corrosion cracking owing to eliminating the keyway structure and has lower stress due to its monoblock rotor. This paper reports the design, operation, and replacement work of the low-pressure turbine with 54-inch blades.

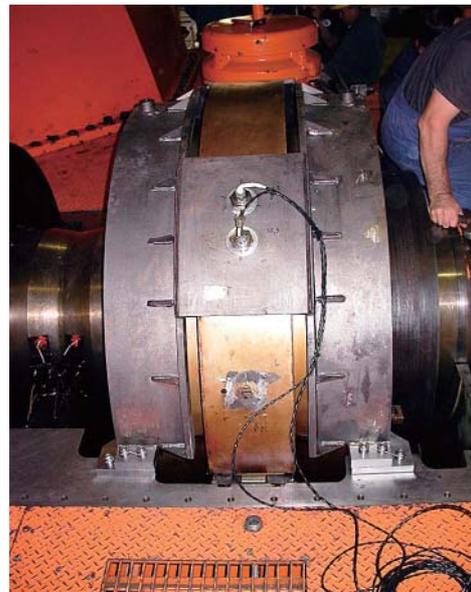
Fig. 4 Mounting of Torsional Vibration Measuring Pickups

machine was measured because the generator was out of scope and it had unknown torsional vibration characteristics. Using the three-dimensional measurement results, a bracket for the pick-ups was designed which could be installed on a narrow pedestal. The pick-ups were installed onto the bracket to measure the natural torsional frequency (Fig. 4). The results coincided closely with the predicted values, and a torsional natural frequency near 100 Hz, which is particularly important for design, was less than 0.1 Hz different from the predicted value. As a result, the validity of the analytical model of torsional vibration including the generator was verified, and high torsional vibration reliability was realized.

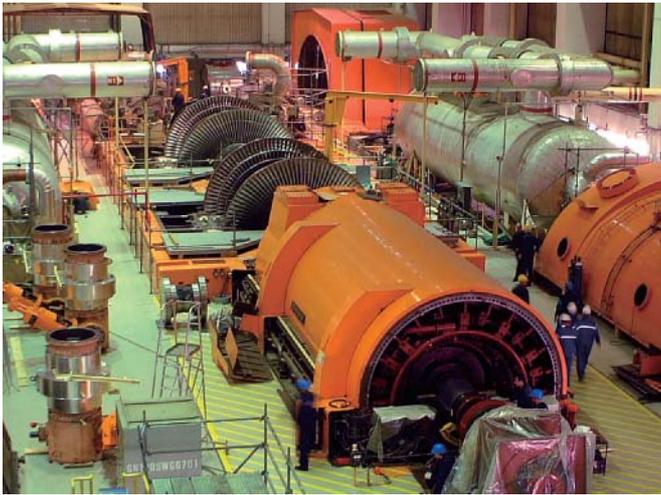
Fig. 8 Scene of Replacement Work

The field work period was shortened by preparatory steps in design, such as replacing the inner casings, jack shafts, glands, and oil retaining rings, fitting hydraulic coupling bolts and hydraulic wrench for inner casing bolts and preparing spare parts for work. The field work period was also shortened by a strict schedule plan, the employment of skilled field workers, cooperative negotiations with the customer, and a three-shift working system. As a result, the replacement work was completed in 27 days, one day earlier than planned. A replacement work scene is shown in Fig. 8.
