Inspection Service for Plant and Piping Equipment Utilizing Eddy Current Testing (ECT) in Lieu of Surface Inspection (MT/PT)

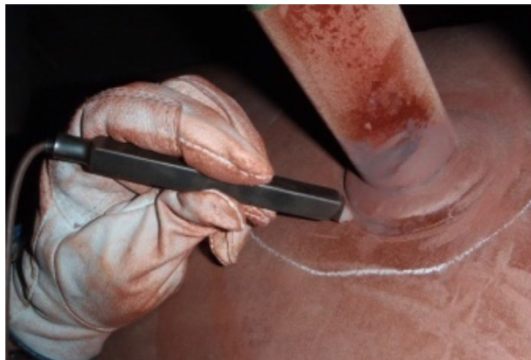
Figure 2 and **Figure 3** show the ECT probes MHI developed for use in ECT in lieu of MT/PT. We developed a pencil-type ECT probe⁽³⁾ and an array ECT probe that can be equipped with multiple coils. First, the pencil ECT probe shown in Figure 2 consists of a pencil-shaped holding part and a small coil. The small coil is mounted on the tip of the sensor and embedded in a low-friction material. Defect detection is performed by bringing the tip of the sensor into direct contact with the area to be inspected. The pencil-type sensor is easy to hold and can perform inspections with relative ease.

Figure 2 Pencil ECT probe

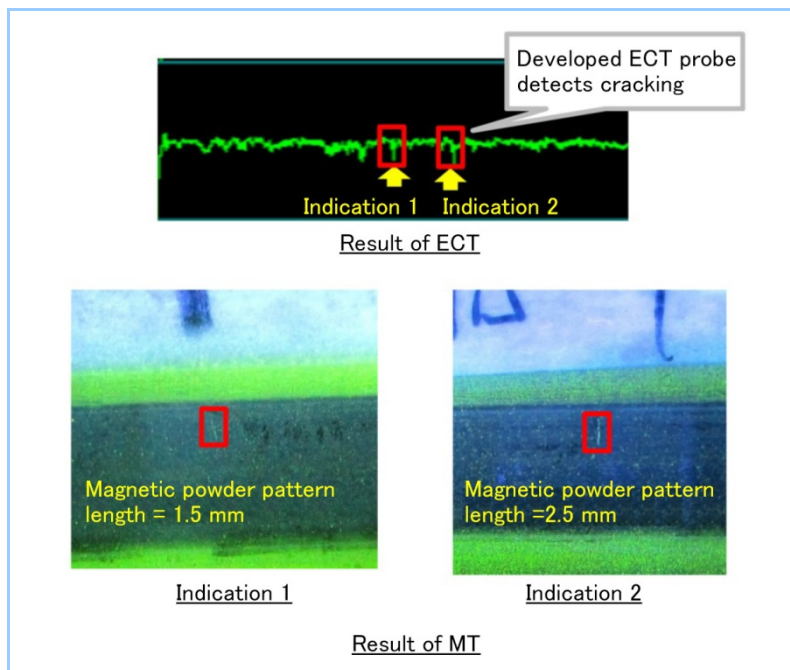
Figure 7 shows the results of ECT and MT to evaluate the validity of the ECT. Crack signals were detected in two locations as a result of the ECT verification test, and MT was performed to evaluate the validity of the ECT results. As a result, 1.5-mm- and 2.5-mm-long magnetic powder patterns were detected at the locations where cracks were detected by ECT. This indicates that the actual cracks are detectable by ECT and that there are no problems with its detectability.

Figure 7 Results of ECT and MT

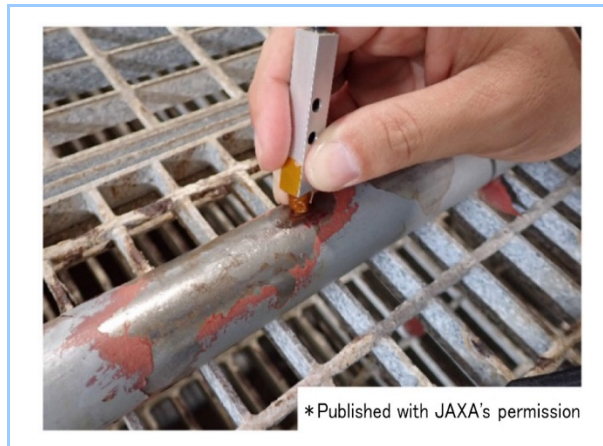
Figure 9 shows the ECT inspection work on the outer surface of stainless steel piping. The inspection flow consists of a visual inspection to select a rusting area that may be corroded, and then evaluation of the presence or absence of defects by applying ECT to the area. Because the stainless steel high-pressure gas piping in the launch pad is sometimes located in narrow areas due to facility constraints, a pencil-type ETC probe, which is compact and easy to scan, was used.

Figure 9 ECT inspection work on outer surface of stainless steel piping
