High-Efficiency Inspection Service of Plant Facilities Utilizing Ultrasonic Technology that Contributes to Process Shortening

In thermal, nuclear, and other power generation plants, there is a need to shorten the periodic inspection process, and the establishment of highly efficient inspection services is desired. However, since the inspection of corrosion thinning of plant piping and boiler heat transfer tubes entails incidental work such as temporary scaffolding and removal of scale on the outer surface of the tubes, there is an issue of reducing the time and cost associated with such incidental work. As a measure to address the issue, we have developed an inspection service that can efficiently screen the wall thinning of plant piping with minimal incidental work, and an inspection service that can measure the wall thickness and inner scale thickness of boiler heat transfer tubes without removing the outer surface scale. These services reduce the amount of incidental work required for the inspection of corrosion thinning in plant facilities, which contributes to shortening the periodic inspection process.

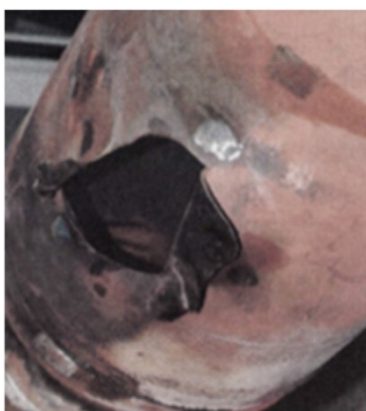
Figure 1 Example of damage to plant piping (flow accelerated corrosion (FAC))

First, this paragraph describes examples of damage to plant piping and the issue of conventional inspection methods. As shown in **Figure 1**, plant piping may incur corrosion thinning

such as FAC (Flow Accelerated Corrosion) and CUI (Corrosion Under Insulation) on its inner and outer surfaces, so it is necessary to periodically inspect piping to understand the occurrence of damage. The methods to understand the damage condition, for example, ones for plant piping of thermal power generation facilities, are described in Codes for Thermal Power Generation Facilities -Rules on Pipe Wall Thinning Management for Thermal Power Generation Facilities⁽⁴⁾ issued by the Japan Society of Mechanical Engineers. In this code, periodic inspection and trend monitoring of corrosion thinning for main water pipes and main two-phase flow piping are required. Currently, plant piping inspections mainly employ ultrasonic wall thickness measurements and visual inspections, but depending on the inspection site, temporary scaffolding and removal of thermal insulation may be necessary, resulting in a significant amount of time and cost for the incidental work necessary for the inspection. In addition, shortening the periodic inspection process has been promoted recently, and in some cases, the inspection target areas are limited based on past inspection records and actual results. However, depending on the plant operating conditions, the areas targeted for inspection may not always be the areas with the greatest risk of damage. Therefore, for the inspection of the piping for corrosion thinning, there is an issue of establishing a highly efficient inspection method that can minimize the amount of incidental work and quickly inspect areas with the risk of damage without any omissions.

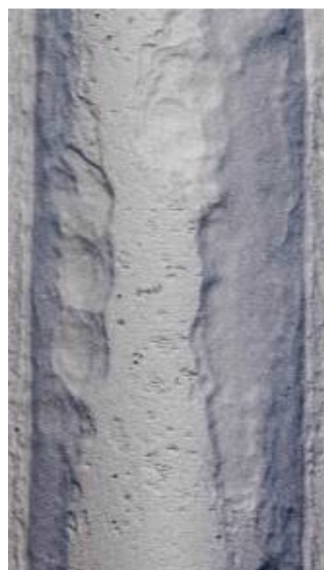
Figure 2 Example of damage to boiler heat transfer tube (sulfide corrosion, with outer surface scale removed)

Next, this paragraph describes examples of damage to heat transfer tubes in boiler facilities of thermal power plants and the issue of conventional inspection methods. Boiler heat transfer tubes may incur sulfide corrosion of the furnace evaporator tubes shown in **Figure 2** and pitting corrosion of the inner surface of the tubes, and as is the case with plant piping, ultrasonic wall thickness measurements and visual inspections are performed. As a parameter for life evaluation with respect to creep damage occurring in boiler heat transfer tubes, it is necessary to know the temperature of the metal exposed during boiler operation. One of the methods for this purpose is to measure the thickness of the inner surface scale (steam oxidation scale) formed on the inner surface of the tube using ultrasonic to estimate the metal temperature based on the thickness⁽⁵⁾. This measurement for both the wall thickness and the inner surface scale is performed by applying an ultrasonic probe (sensor) to the outer surface of the tube and analyzing the ultrasonic signals from the sensor to measure the respective thicknesses. However, the outer surface of boiler heat transfer tubes is covered with outer surface scale (atmospheric oxide scale), which needs to be removed before inspection, and the removal of this outer surface scale requires sandblasting or grinding with a grinder, which results in a significant amount of time and cost. Therefore, for the inspection of boiler heat transfer tubes for corrosion thinning, there is an issue of establishing an inspection method that can eliminate the removal of outer surface scale, which is a bottleneck in reducing the time and cost of the inspection.

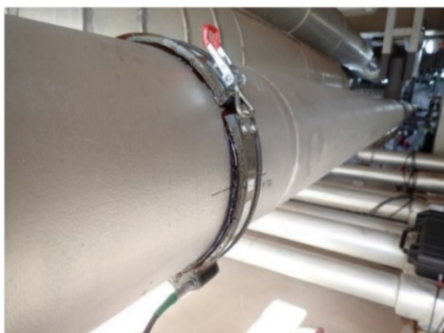
Figure 4 shows the developed guided wave sensor. This sensor is a ring-shaped, multi-channel type having multiple transmitting and receiving channels in its circumferential direction. By processing the signal obtained from multiple receiving channels using the FMC/TFM (Full Matrix Capture and Total Focusing Method) ⁽⁷⁾ to improve SNR (Signal-to-Noise Ratio), this sensor is capable of detecting defects in the elbow area, where the guided wave technology was thought to be difficult to apply in the past ⁽⁸⁾. The inspection results are also displayed as a color map processed by FMC/TFM, allowing for visual understanding of the location information of reflection sources such as wall thinning and cross-sectional shape changes. An example of the output of the inspection results is shown in the verification test results in section 3.2.

Figure 4 Guided wave sensor

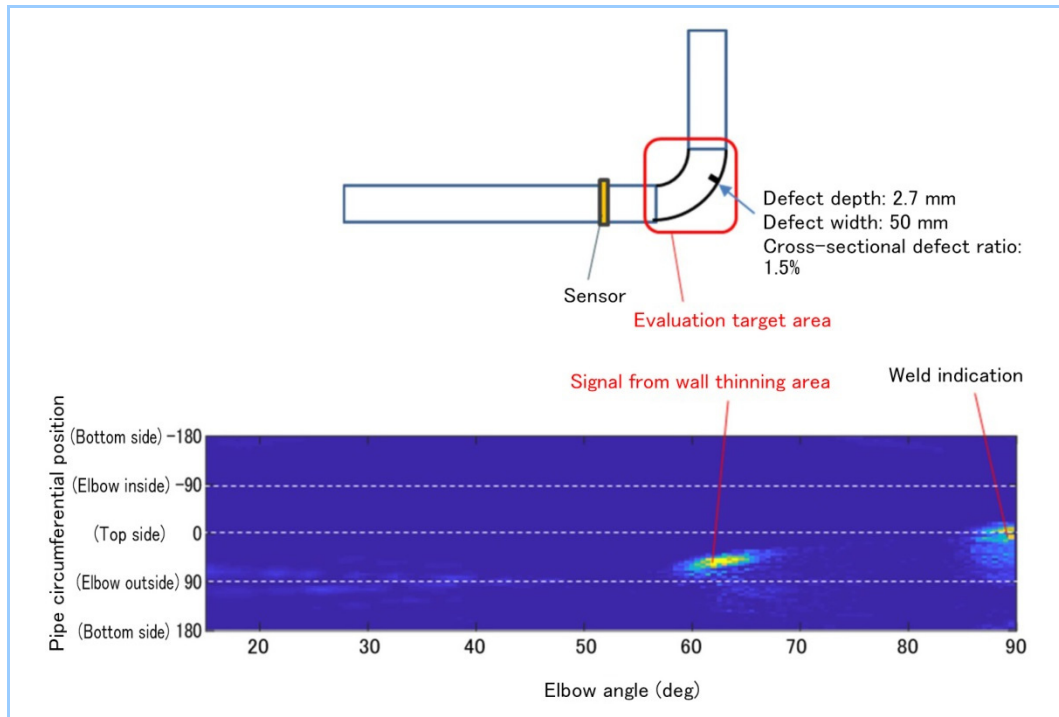
Figure 6 shows the results of the verification test using a mock-up pipe with an elbow section. An artificial defect with a cross-sectional defect ratio of 1.5% was applied to the outer surface of the mock-up pipe on the back side of the elbow section. As a result of the verification test, signals with sufficient SNR were obtained from the artificial defects at the elbow section. Therefore, it was determined that the technology could be applied to the elbow section as well. This technology can evaluate the presence or absence of wall thinning in the longitudinal and circumferential positions of the pipe, but it cannot measure the wall thickness.

Figure 6 Mock-up pipe verification test results (elbow)

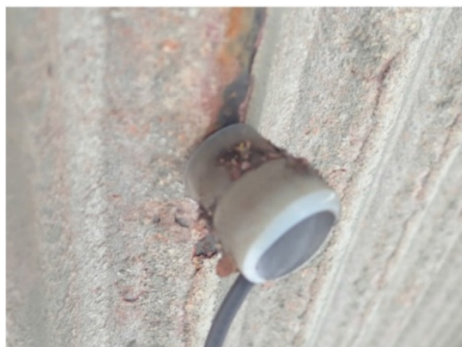
Figure 8 Appearance of EMAT

To solve the issues related to boiler heat transfer tube inspection described in Chapter 2, we considered that it is effective to have a technology that can measure the wall thickness of a tube from above the scale formed on the outer surface of the tube. Therefore, we focused on electromagnetic ultrasonics, which enables non-contact thickness measurement by generating eddy currents on the outer surface of a heat transfer tube even when outer surface scale is formed there, and developed a measurement method using an EMAT capable of generating electromagnetic ultrasonic waves. **Figure 8** shows the appearance of the EMAT and **Figure 9** shows its configuration. An EMAT mainly consists of a permanent magnet and a coil, and electromagnetic ultrasonic waves are generated by applying a high-frequency current to the coil⁽⁹⁾. The wall thickness measurement method is similar to the conventional ultrasonic wall thickness measurement. The EMAT is placed on the outer surface of the tube to be measured. Electromagnetic ultrasonic waves are applied to the inner surface of the tube, and the reflected signal from the inner surface is detected. The wall thickness is calculated from the arrival time. The developed EMAT has a permanent magnet of optimized size and a coil of optimized wire diameter and number of turns in order to increase the signal intensity of the ultrasonic generated by the excitation.

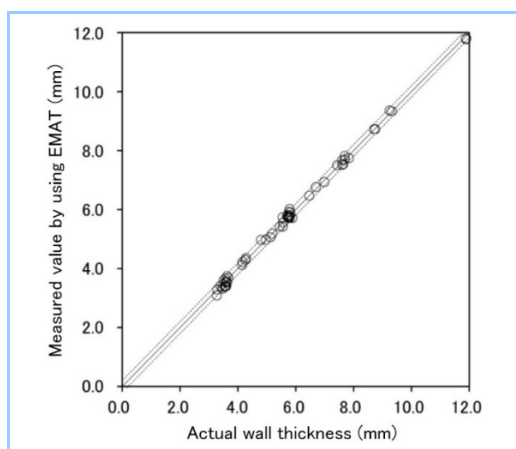
Figure 11 compares the wall thickness values measured by using EMAT and those actually measured. **Figure 12** compares the inner surface scale thickness values measured by using EMAT and those actually measured. The error in the wall thickness value measured by using EMAT with respect to that actually measured was ± 0.2 mm or less. The error in the inner surface scale thickness with respect to that actually measured was ± 50 μm or less. This indicates that both cases attained measurement with high accuracy.

Figure 11 Verification test result (wall thickness)

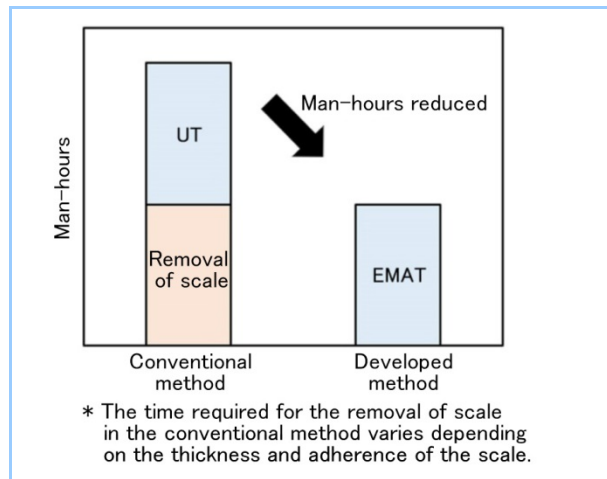
Figure 13 compares man-hours required for inspection between the conventional method using UT and the developed method using EMAT. The application of EMAT eliminates the need for

the removal of outer surface scale, which was conventionally required, and is estimated to reduce man-hours by about 50%, depending on the conditions. In addition, since scale removal by sandblasting generates dust, other operations such as welding cannot be carried out simultaneously in many cases, but this technology allows other operations to be carried out simultaneously. Furthermore, this technology can prevent wall thinning of heat transfer tubes due to sandblasting.

Figure 13 Image of man-hours reduction due to EMAT
