Measurement Experience of Lightning Currents to Wind Turbines

YOSHINORI UEDA*1 SHINJI ARINAGA*2
 MITSUYOSHI FUKUDA*3 NOBUKI IWAI*3
 TAKATOSHI MATSUSHITA*3 KOSUKE INOUE*1

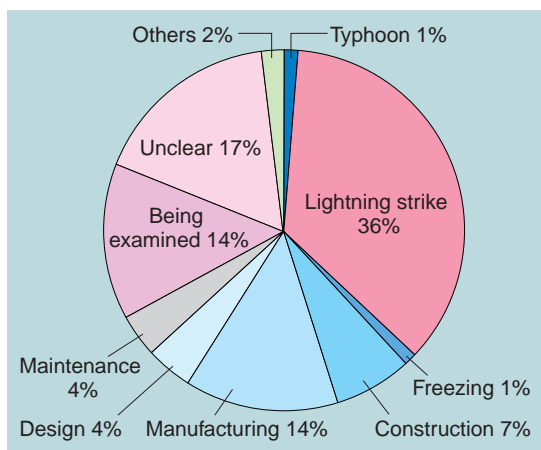
Fig. 1 Causes of failures of domestic wind turbines⁽⁴⁾

the most frequent is lightning strikes⁴ (Fig. 1). The winter lightning in the coastal area of the Japan Sea in the Hokuriku region causes especially great damage, mainly to the wind turbine blades^{2, 5, 6} (Fig. 2). Winter lightning has much larger energy than ordinary lightning. The temperature differential between the warm ocean current in the Japan Sea and cold air mass in the atmosphere causes vast lightning clouds to develop and to discharge the accumulated electricity at once. To design wind turbine blades capable of withstanding the large energy discharged, the properties of the winter lightning must be grasped in quantitative terms. To attain such a grasp, MHI has observed and measured "Winter lightning" which strike actual wind turbines in Japan since 2002. The company has also participated in the NEDO research projects described above.

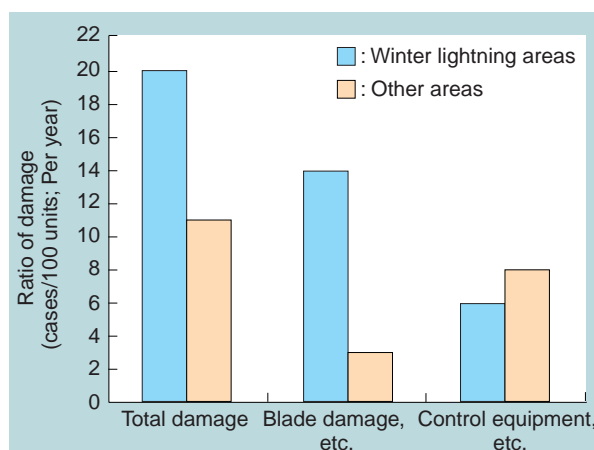
Fig. 2 Frequency of damage to wind turbines caused by lightning⁵

measurement apparatus for lightning stroke measurement, there was a bias for wind turbines with a higher risk of attracting lightning (based on past records of lightning strikes, terrain, and region). In addition, this frequency is one digit higher than the rate of damage due to lightning strikes calculated by NEDO (0.2 times per unit per year; see Fig. 2). It seems that in some cases, lightning inflicts no damage to a wind turbine when it strikes.

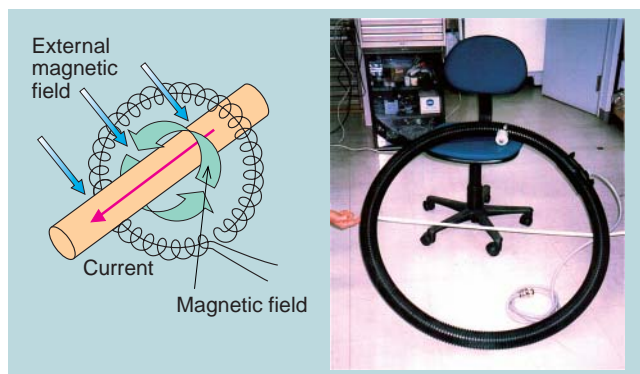
Fig. 3 Structure of Rogowski coil

With any attempt to measure a large lightning current directly, the measurement equipment is threatened by the risk of burnout. As an alternative, the lightning current can be measured indirectly based on a non-contact method.⁷ A Rogowski coil (Fig. 3) with a large bore diameter is looped around the tower base of a wind turbine (and the main shaft at the Goishigamine site), for use as a current sensor (Fig. 4). When lightning strikes the turbine and the current passes inside the loop, a magnetic field is generated and an induced current flows through the Rogowski coil. The magnitude of the original lightning current (charge amount; coulomb) can be determined by calculating the rate of change in the magnetic field from the induced current measured, and then integrating the rate of change. The composition of the measurement device is shown in Fig. 5. The Central Research Institute of the Electric Power Industry (CRIEPI) and Hokuriku Electric Power Co. originally developed this measurement technique while researching ways to protect transmission line towers from lightning strikes. Later, Toko Electric Co. applied this measurement technique to the tower base of a wind turbine and used actual equip-

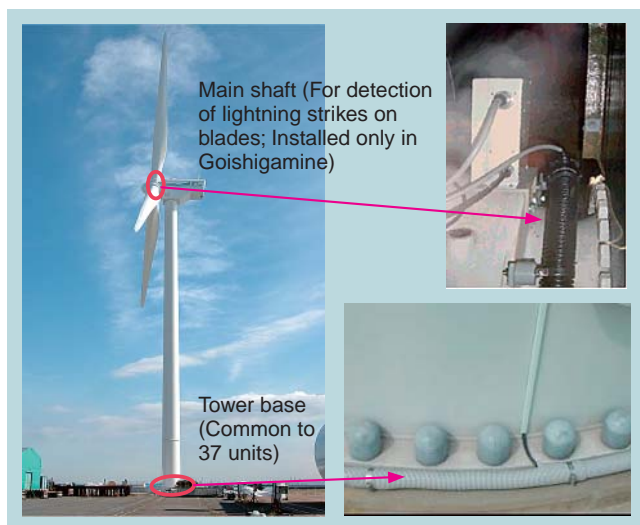
Fig. 4 Lightning current measurement device

MHI started its lightning observations in the 600 kW wind turbine set up at the peak of Goishigamine, at the root of the Noto Peninsula in Ishikawa Prefecture, in 2002. The Rogowski coil was set in two places, i.e., the main shaft and tower base, to distinguish between the lightning strikes on the turbine blades and those on the lightning conductor on the nacelle (Fig. 4). MHI also installed a lightning strike observation camera (Fig. 6) in cooperation with the Lightning Center of Hokuriku Electric Power Co., in order to establish a system to visually observe areas struck by lightning.

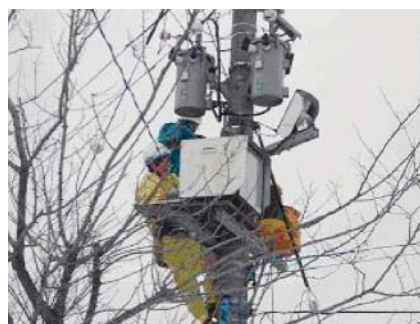
Fig. 6 Camera observation device for lightning strikes

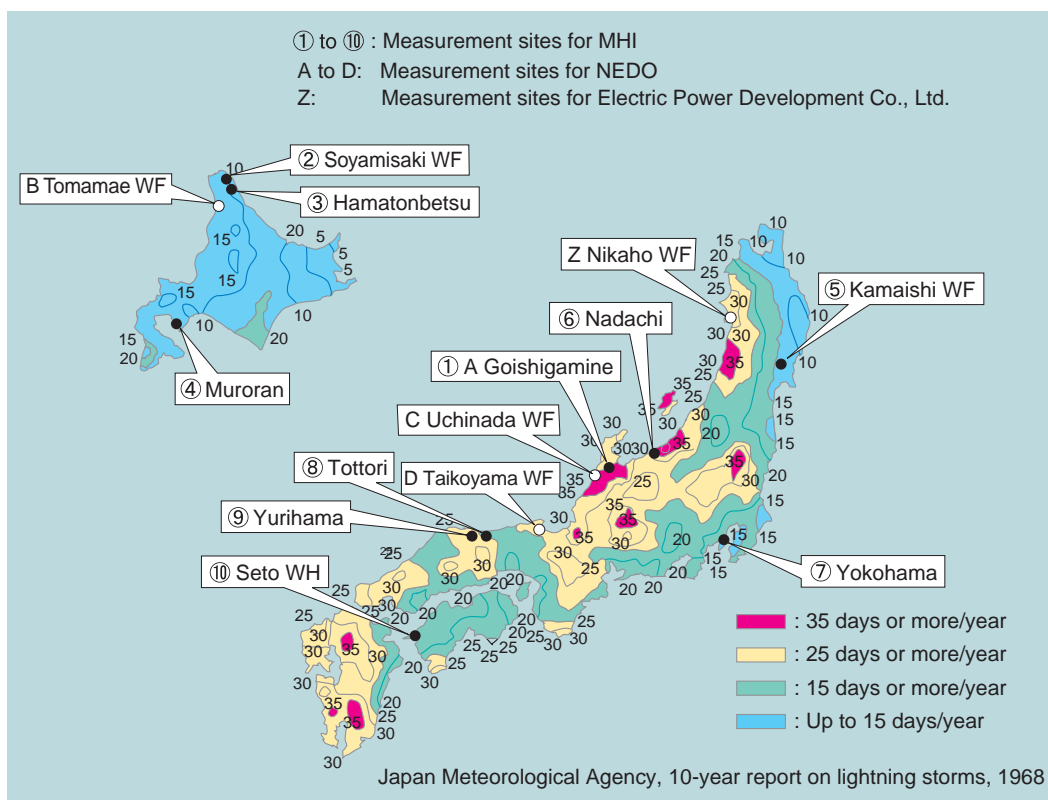
Fig. 7 Lightning observation implementation sites

Based on the observation experience in Goishigamine, MHI started to increase the number of measurement sites in 2005. Over the past two winters, 2005-2006 and 2006-2007, the company has collected lightning-observation data using 37 units installed at ten measurement sites in various regions of the country (Fig. 7 and Table 1). The sites are geographically arranged in a configuration that will hopefully determine the boundaries of areas threatened by winter lightning dangers, with help from supplementary data collected at four surrounding sites operated under the NEDO studies on winter lightning. To share information, the NEDO study also relies on measurement data from MHI's lightning observation in Goishigamine, Ishikawa Prefecture. In addition, Electric Power Development Co., Ltd. is measuring lightning strikes in Nikaho, Akita Prefecture, independently from the NEDO research² (Table 1).

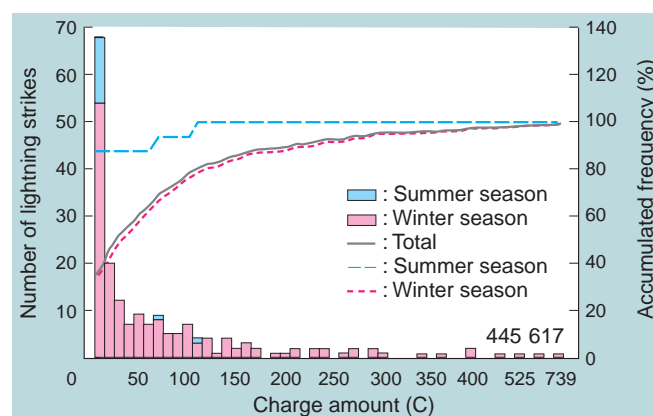
Fig. 8 Distribution of lightning currents observed

Figure 8 shows the results of observations of the lightning current for two winters during the period from September 2005 through April 2007. According to our analysis of frequency distribution of lightning currents by magnitude shown in the figure, larger currents tended to be less frequent. Observation values exceeded protection level I (300 coulombs: Refer to Table 3) of the international design standard IEC 61400-24⁹ ten strikes at four sites: Goishigamine, Tottori, Yurihama and Uchinada (NEDO) (all in winter lightning areas) (Table 4). On December 22, 2005, large lightning strikes were measured in multiple sites. The weather map¹⁰ on this day showed a strong winter pattern (Fig. 9).

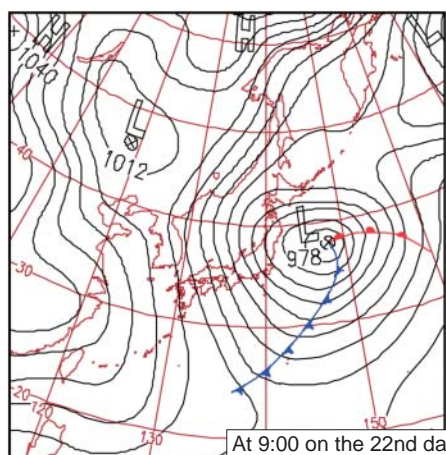
Fig. 9 Weather map (December 22, 2005)

On the 22nd day (Thursday), a strong winter pattern prevailed again. The temperature at an altitude of about 5 200 m over Yonago City, Tottori Prefecture was -40°C or below. Akita City had 56 cm snowfall and Kagoshima City had 11 cm. Both cities broke their deepest snow records for December for the first time in 88 years. Hachiojima-machi, Tokyo, had a maximum instantaneous wind speed of 38.2m/s (northwestward).

A cold air mass moved over even the western part of Japan. The temperature difference from the warm ocean current in the Japan Sea expanded, and lightning clouds developed over wide areas, bringing about snowfall and lightning strikes. The biggest lightning charge, a 739-coulomb strike, struck Tottori on December 6, 2005. As on the 22nd later in the month, the weather map on this day (Fig. 10) showed a cold air mass over even the western part of Japan. Winter lightning apparently results from "a large temperature differential in the terrestrial airspace between the warm ocean current of the Japan Sea and the cold air mass up in the sky."

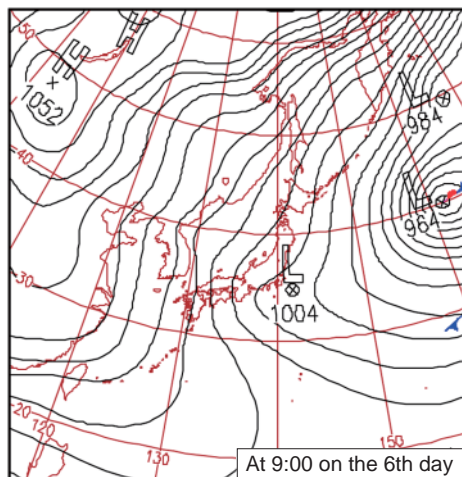
Fig. 10 Weather map (December 6, 2005)
On the 6th day (Tuesday), heavy snow fell mainly in the western part of Japan. Cold air continued to flow mainly into the western part of Japan. Snowfall over the 24-hour period up to 9:00 was 71 cm in Gujo City, Gifu Prefecture; 40 cm in Maniwa City, Okayama Prefecture; and 38 cm in Shobara City, Hiroshima Prefecture. In Gujo City, Gifu Prefecture, the accumulation of snow reached 119 cm.

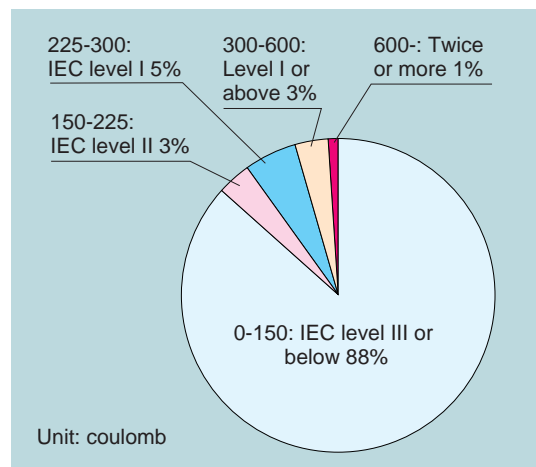
Fig. 11 Distribution of lightning current probability

Figure 11 shows the probability lightning strikes based on magnitude, systematically arranged according to the IEC's protection level. The probability of a lightning strike at IEC protection level I or more is about 4%, and that of a strike with a magnitude of double level 1 or greater is 1% or more. When the high lightning-strike frequency shown in Table 2 is also considered, we can see that winter lightning in the Hokuriku region is a weather phenomenon specific to Japan and beyond the assumptions of IEC.

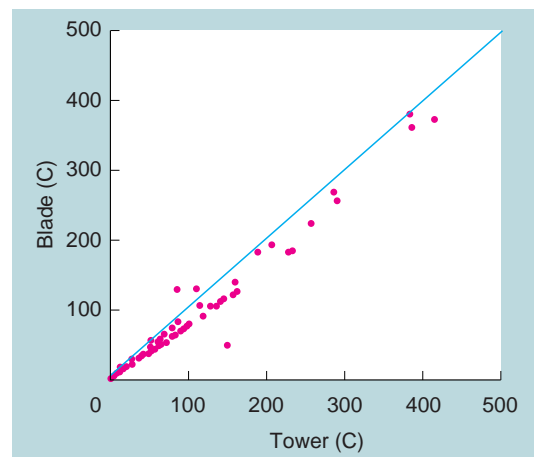
Fig. 12 Comparison between the current value in the blade and that in the tower base

When the turbine operated with non-receptor blades, lightning struck the blades and the lightning conductor on the nacelle at a nearly fifty-fifty ratio. After the receptor blades were adopted, lightning struck the blade receptor with 100% probability (Table 5 and Fig. 12).

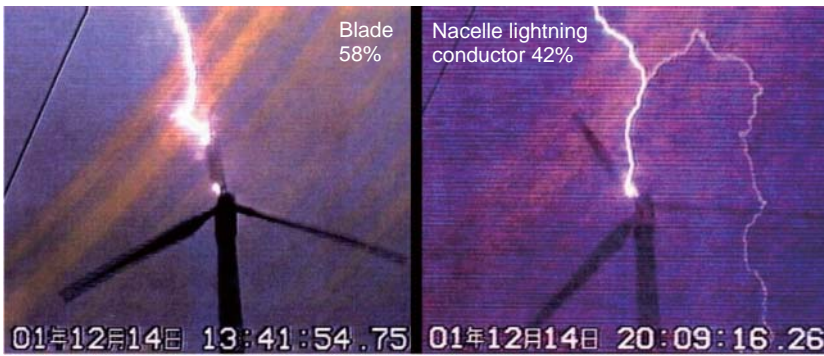
Fig. 13 No-receptor period

This was confirmed by camera observation (Fig. 13 and Fig. 14). It also appears that the overall frequency of lightning strikes on the wind turbines increased by 1.5 to 10 times after the receptor blades were replaced. But given that the seasonal variation was as large as 1.5 times to 5 times, we cannot affirm that the blade replacement had a decisive effect.

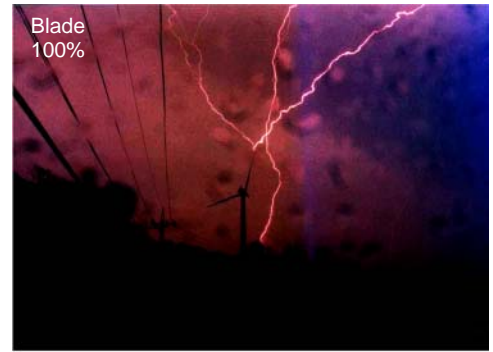
Fig. 14 After a receptor was adopted
