Realization of Advanced After-sales Service for Long-term Operation at Nuclear Power Plants

This report introduces two representative examples, "Accomplishment of the world's first replacement work of core internals of a 3-loop*¹ PWR plant" and "Development of SG internal inspection and high-pressure water cleaning jigs."

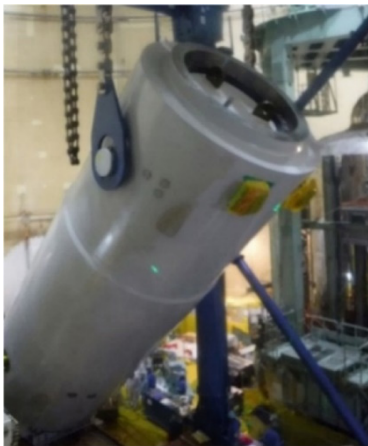
Figure 1 Shielding container for old CI overturned by special crane in CV

- (b) Carrying-out equipment: When the shielding container (600 tons) for old CI which is an unprecedentedly superheavy load is carried from the CV outdoors through the E/H, it needs to pass through a gap of at least 100 mm. Therefore, we developed dedicated temporary carrying-out equipment.
- (c) Special crane in CV: The existing polar crane in the CV cannot lift and place sideways the shielding container weighing 600 tons. Therefore, we developed a special crane, which works even in the limited space in the CV, in cooperation with an overseas company (**Figure 1**).

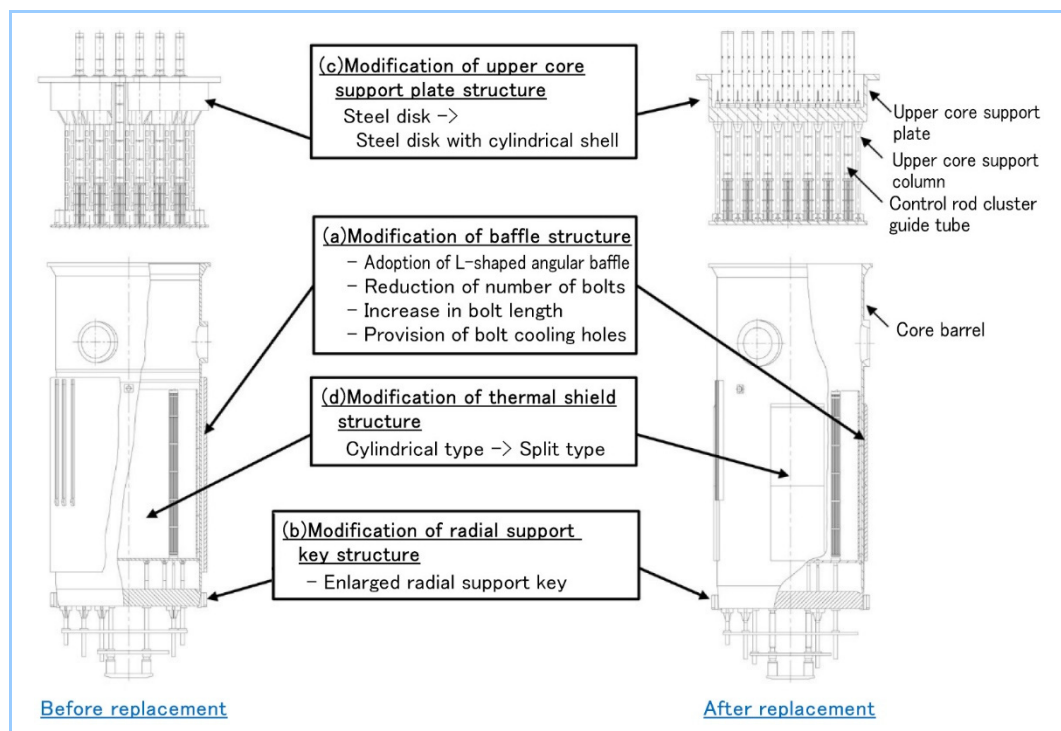
The new CI is based on the improved standard 3-loop plant. It has design improvements, mainly for preventive maintenance for damage of baffle former bolts and improvement in the seismic resistance margin, compared to the old CI, as shown in **Figure 2** and below.

Figure 2 Major design improvements of new CI compared to old CI

- (a) Modification of baffle structure
For the new CI, an L-shaped baffle (integrated type) instead of the conventional split-shaped core baffle was adopted to increase the rigidity and reduce the stress on baffle former bolts through an increase in length. In addition, bolt cooling holes were provided to reduce the environmental temperature as a preventive measure against irradiation-assisted stress corrosion cracking.

- (b) Modification of radial support key structure
Compared to the conventional radial support key, the radial support key of the new CI increased in size and the number and diameter of the bolts used for installation also increased so that the seismic resistance was improved.

- (c) Modification of upper core support plate structure
The steel disk was changed to a steel disk with a cylindrical shell to reduce the length of the upper core support column and control rod cluster guide tube to improve the resistance to cross-flow fluid load and seismic load.

- (d) Modification of thermal shield structure
The cylindrical type shield, which coats the entire core barrel, was modified to a split type shield, which coats only the vicinity of the direction of the maximum neutron flux, to improve manufacturability.

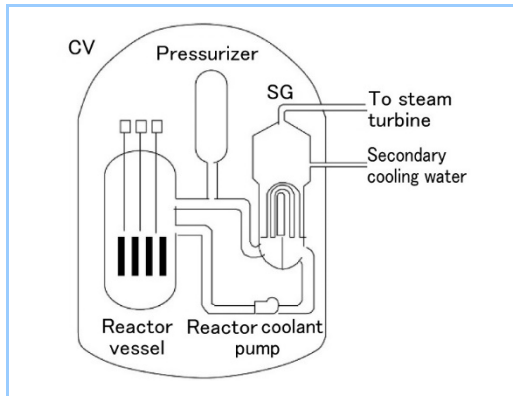
Figure 5 Overview of main cooling system of reactor cooling system of PWR
