Successful Return to Flight of the H-IIA Launch Vehicle

Since the failure of H-IIA flight No.6 in November 2003, launch of H-IIA had been suspended. To make H-IIA launch resume through lessons learned from this failure, corrective actions were taken not only to improve the cause of failure itself but also to improve the H-IIA reliability through re-evaluation of overall H-IIA development process. Then the improved H-IIA was launched on February 26, 2005 and returned to flight successfully. This paper describes the activities for the return to flight of H-IIA and the results of the flight.

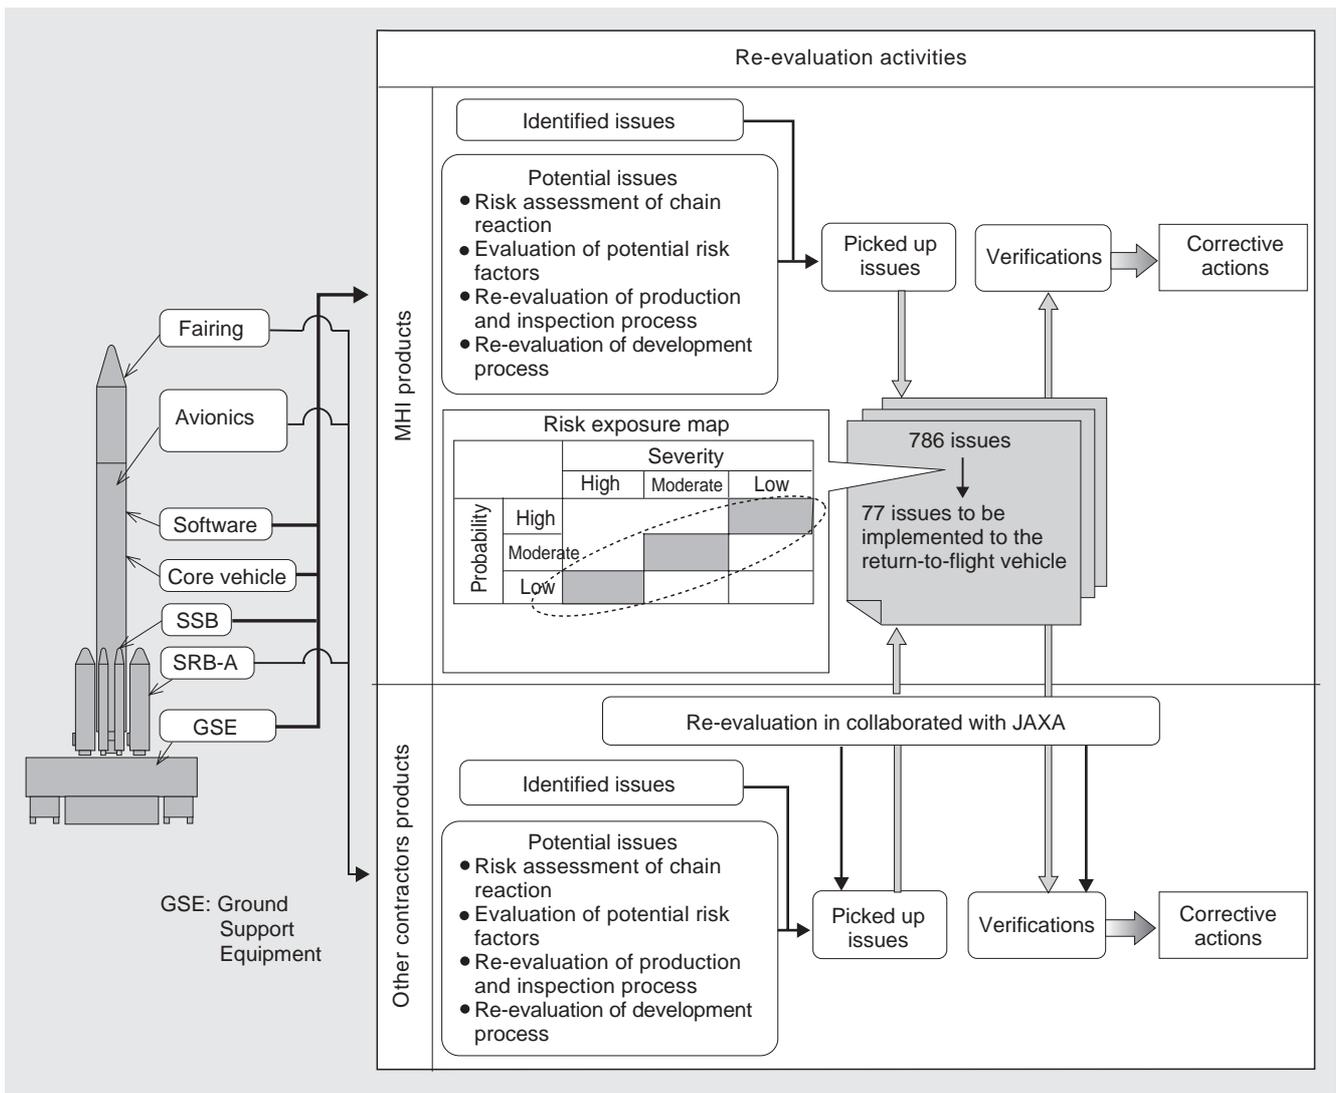
Fig. 5 Flowchart of re-evaluation activities of the H-IIA launch vehicle

On reflection from the accident of Flight No. 6, re-evaluation of the whole H-IIA launch system was thoroughly performed into its basic design and development process. This re-evaluation activity collected issues to be assessed in terms of the probability of a risk occurring and the severity of the consequences (Fig. 5). This activity picked up 786 potential issues and selected 77 items to be implemented to the return-to-flight vehicle.

For example, following improvements were implemented to H-IIA:

- to protect critical wire harness and detonating fuse adjacent to engines or to change routing of these against potential hot gas leak from engines.
- to reposition critical equipments, fuses and harnesses against potential hot gas leak from SRB-A nozzle.
- to change installation of flight safety instruments.
- to add flight monitor channels.

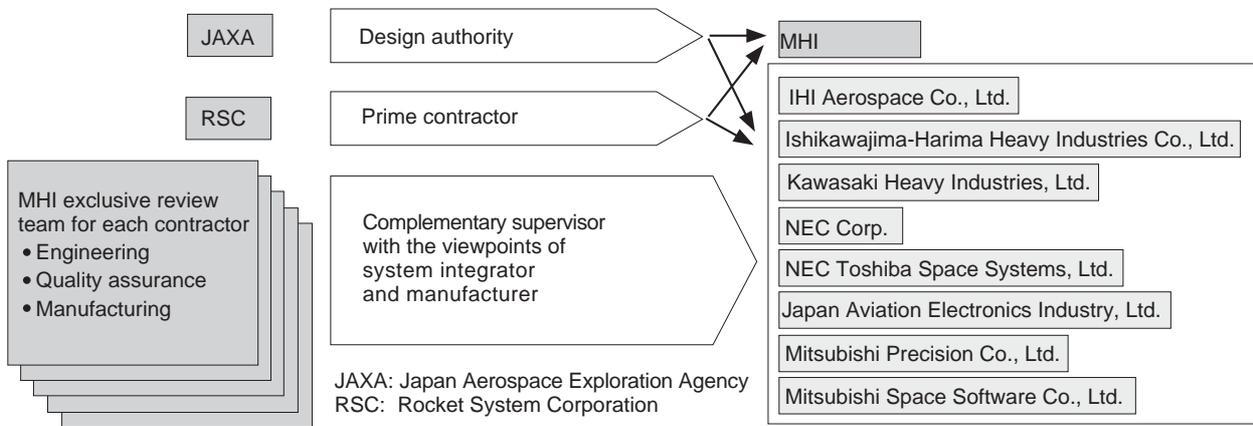
Fig. 6 Activities to verify the reliability of other contractors products

contractors products, such as SRB-A, payload fairing, reaction control system, pyrotechnics, avionics, and so on, which are provided to MHI (Fig. 6).

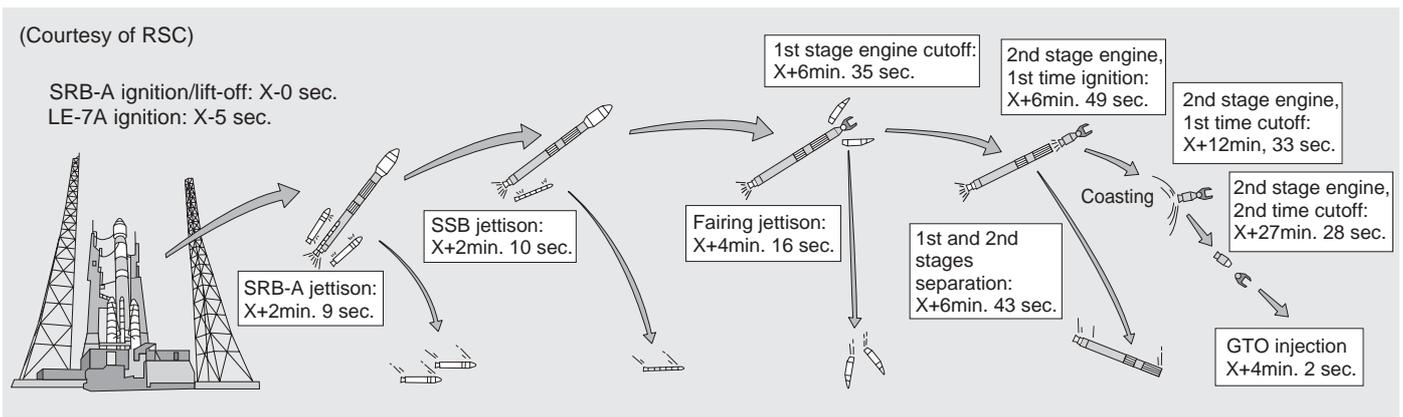
Fig. 7 Flight sequence of H-IIA Flight No.7

H-IIA Flight No.7, which was took the role to return to flight, was launched at 18:25JST on February 26, 2005. The launch vehicle flew smoothly along the planned flight pass (Fig. 7), and injected Multi Transport Satellite-1 Replacement (MTSAT-1R) into the target GTO orbit 40 minutes and 2 seconds after lift-off (Table1).

The flight telemetry data showed that all systems had worked normally, so it was proved that all corrective actions implemented for the return to flight were appropriate. This success has demonstrated that the H-IIA launch vehicle is a highly accurate and highly reliable launch system.
